the ship the treasures the mechanism

Exhibition

The ship

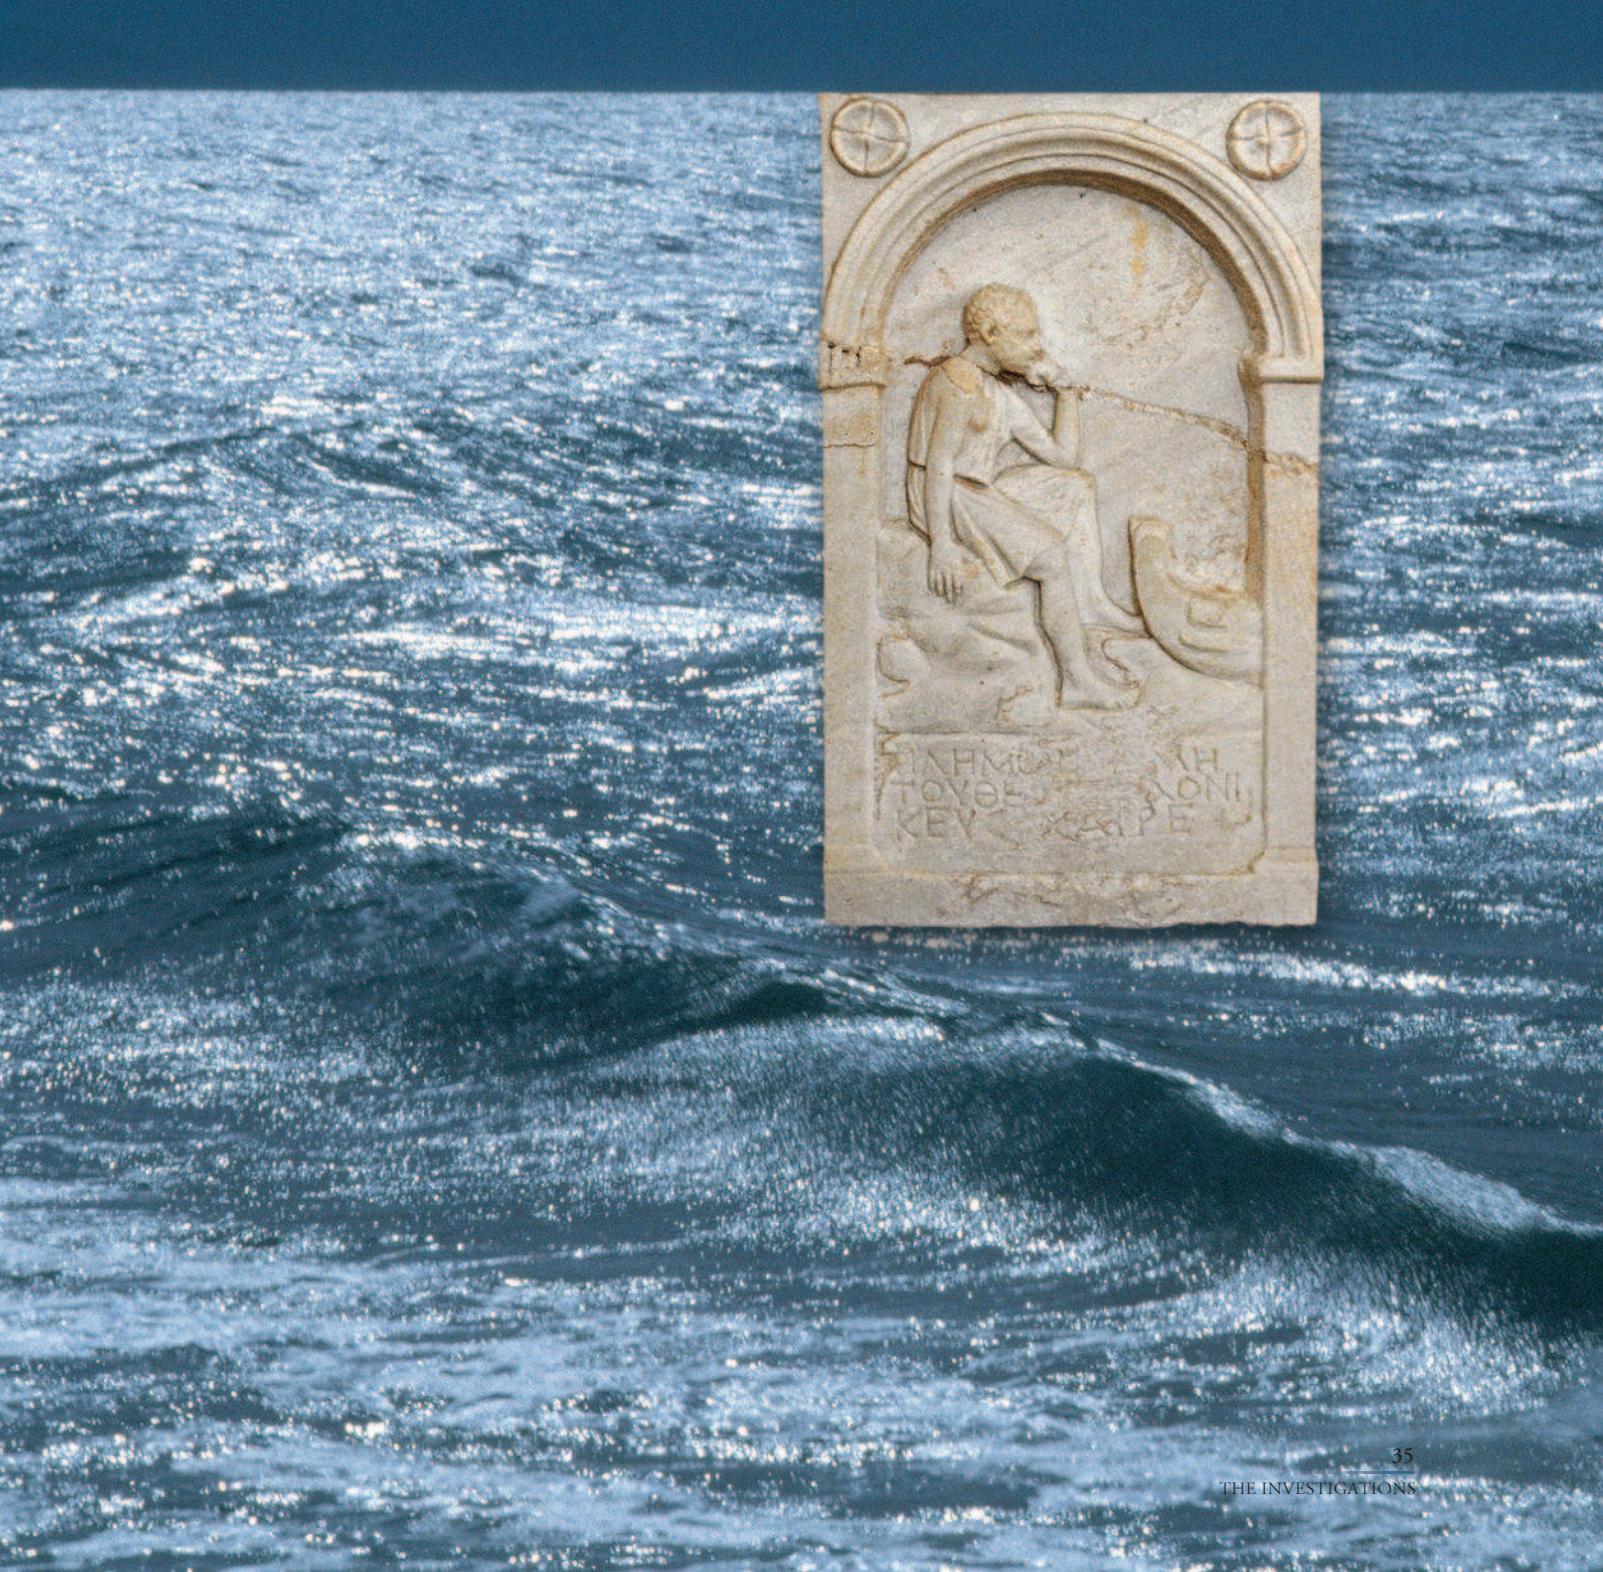
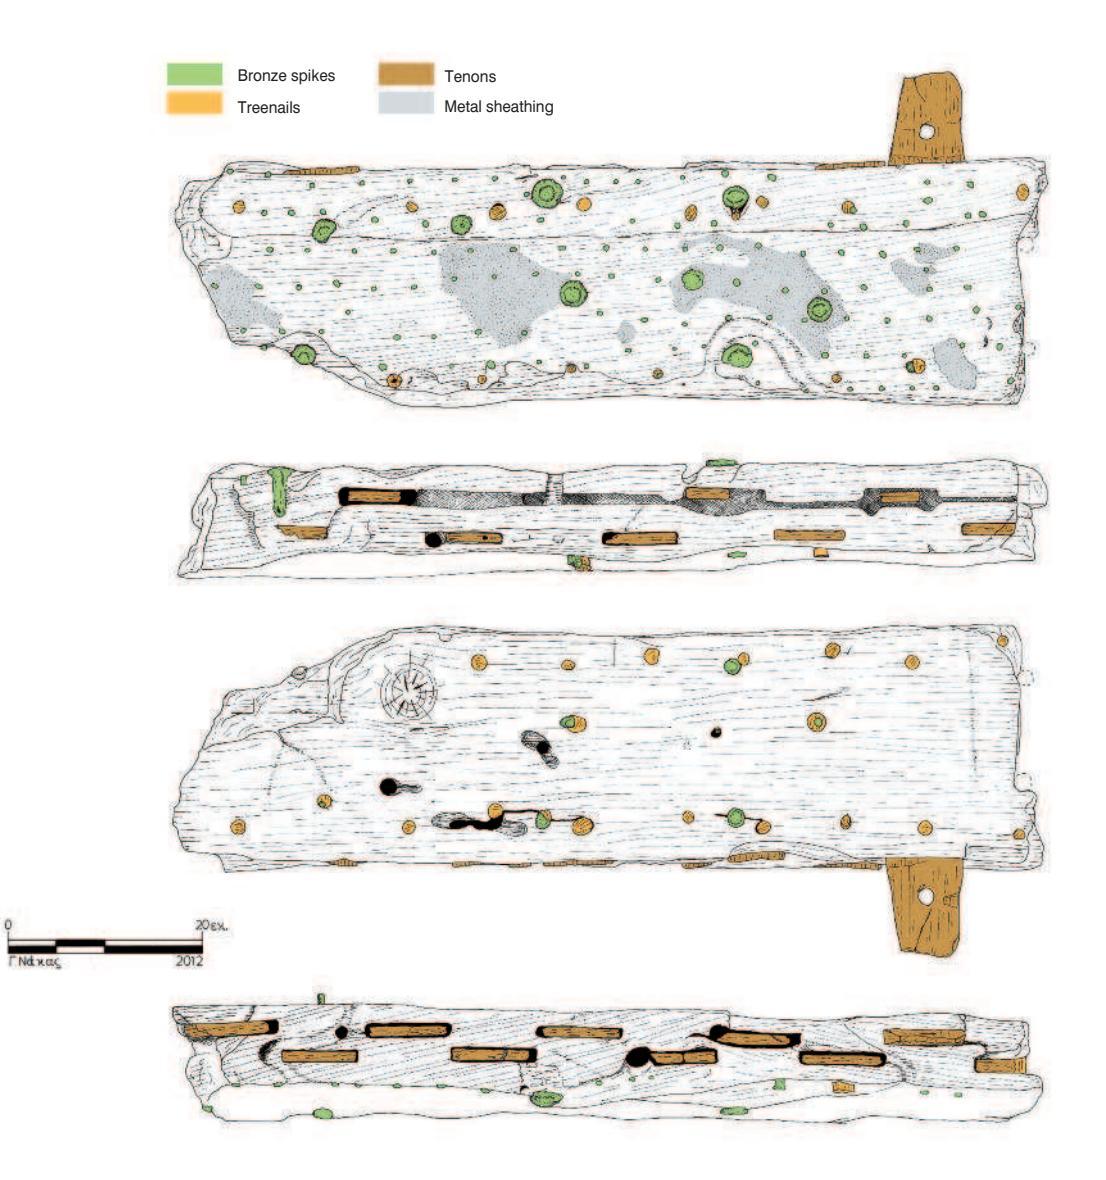
1. FRAGMENT OF A HULL PLANK 220 B.C. (±40) Elm timber L. 0.90 m., w. 0.26 m., th. 0.11 m. From the material retrieved in 1976 Athens, Ephorate of Underwater Antiquities, BE 2011/11

Piece of a plank. It would have been positioned on the lower part of the ship's hull. The wood has suffered surface deterioration and has lost much of its mechanical strength. Damages caused by marine borers (teredenidae) are visible. Mortises in both edges of the plank with half broken tenons surviving in the interior, one of which remains intact. The plank is made of elm timber (ulmus), known in the Aegean region as karagatsi. In traditional shipbuilding, from the existing five varieties of elm, two are primarily used, namely the ulmus montana and the ulmus pedunculata. Elm has been classified as a socalled hardwood. Its timber is relatively heavy, of medium hardness and resilient. In comparison to other timbers of the Mediterranean, it has an inferior mechanical strength though it does not split easily, it dries fast and most importantly it has long life duration. On the other hand, however, it is vulnerable to insects and fungi and has a tendency to warp. Although the use of elm timber was frequently

preferred in water-logged environments, yet in ancient shipbuilding its employment was rather limited. Evidence which derives from some Roman shipwrecks suggests that elm would have been used primarily in the construction of the frames. There are traces of caulking on the outer part of the plank. A layer of resin or pitch would have been placed between the planking and a sheath of lead sheets, to protect the ship's hull against marine borers. The lead sheets were held in place by short bronze nails. On the surviving plank six horizontal, parallel lines of short bronze nails are fixed at a regular spacing of

0.04–0.05 m.: the same distance is kept between each individual line. Particular care is given to the vertical axial alignment of every nail as well: the nails in any one line correlate to the intermediate spacing of those immediately above and below in the guincunx pattern. A consistency in the distribution of the nails is thus achieved most effectively, distributing the stresses evenly and regularly over the area concerned: an essential consideration given that the hull is exposed to heavy vibrations and external pressures. On the outer surface of the plank, seven nails, with round heads of about 0.034 m. in diameter are visible. Their shafts, circular in section, are

driven through wooden treenails, hammered into prefabricated holes that were themselves drilled through the planking and the frames. These nails fastened the planking to the frames. They were hammered in from the outside: two, and in some cases three, nails were required for each frame in each plank.

Especial attention was paid to avoid placing two bordering nails on the same vertical axis: this care reduces the risk of splitting the attached frame. The considerable thickness of the plank allowed the cutting of mortises on the edges in two parallel lines. The broken tenons of the joinery are still visible in these cuttings. They have an elongated

rectangular shape; their sides narrow towards both ends. Their maximum length was 0.22 m., while their width did not exceeed 0.08 m. After the planks were joined together, holes were drilled through them: the tenons were then held firm in position by being transfixed by wooden pegs. Both tenons and wooden pegs were made of oak (querus). Although working oak is considered to be difficult, its timber possesses a high endurance and longevity and only a medium degree of contractionexpansion. These are perfectly appropriate qualities for functional parts such as tenons and pegs. BIBLIOGRAPHY: Unpublished.

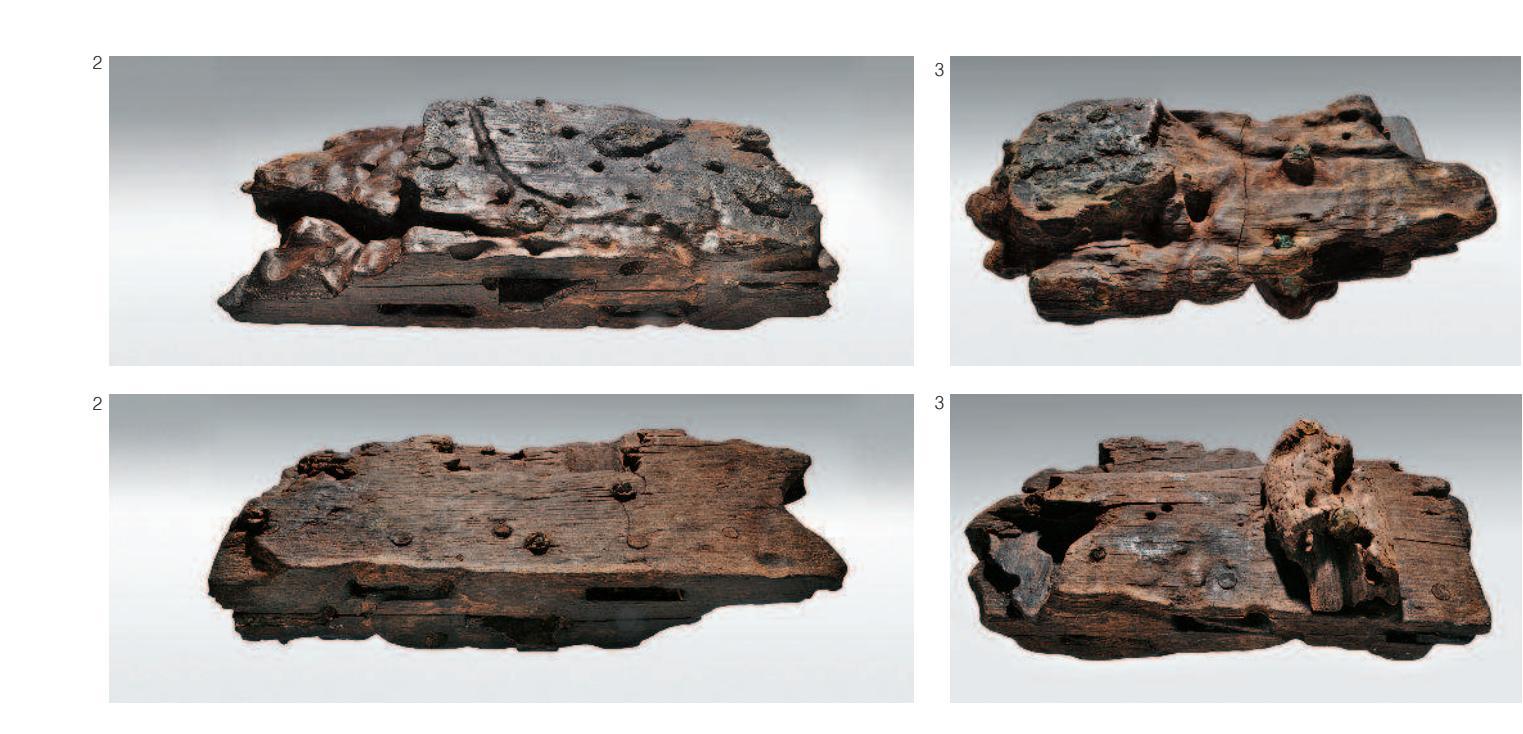
3. FRAGMENT OF A HULL PLANK 220 BC (±40) Elm timber L. 0.48 m., w. 0.25 m., th. 0.095 m. From the material retrieved in 1976 Athens, Ephorate of Underwater Antiquities, BE 2011/13

Plank from the hull of the ship. The wood has suffered surface deterioration and has lost much of its mechanical strength. Damages caused by marine-borers (teredenidae) are visible. A frame is fastened vertically to the inner part of the plank. The frame has shrunk and deformed, due to the loss of the wood's cellulose: therefore it is not possible to estimate what its original size would have been. As in most ancient Mediterranean wrecked ships, the frame would have been rectangular in section, with plane-worked surfaces. The frames were fastened to the ship's hull, after the planking was assembled. The process of joining those two parts started with

the drilling of holes through planking and the attached frame, followed by the insertion of long wooden treenails into the holes. Finally the wooden treenails were themselves transfixed by bronze spikes, hammered from the external side of the planking. This order of procedure, well known already to the shipwrights of the classical period, made possible the protection of the planking from metal corrosion and the pressure applied from the nails and facilitated the replacement of nails if necessary. BIBLIOGRAPHY: Unpublished.

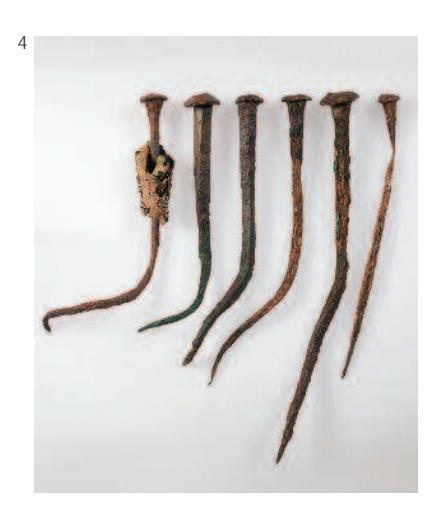
4. BRONZE SPIKES
220 B.C. (± 40)
Copper alloy
L. X 19003: 0.34 m., X 19005: 0.295 m.,
X 19007α: 0.448 m., X 19007β: 0.373 m.,
X 19007γ: 0.33 m., X 19007δ: 0.345 m.
From the material retrieved in 1976
Athens, National Archaeological Museum,
X 19003, X 19005, X 19007α-δ

Forged spikes of copper-alloy from the hull of the Antikythera wreck. The metal has suffered extensive corrosion. Their shafts are twisted, probably from violent detachment of the once-joined parts. The spikes have rounded heads and their shafts are square in section, tapering to a more circular section towards their ends. Below the head, the edges (corners) of the shaft are rounded off. The use of the tetrahedral forged spike is already known in the naval architecture of the Classical period. The advantages of its shape include the ease with which it could be driven home, and its firm grasp once there within the wood along the full length of the shaft (from the progressive narrowing of the same), as well as lack of play, resistance against corrosion and great resistance to lateral tensions (pressures).

Their original position within the structure is unknown. Similar spikes are used to fix the frames to the planking. The fact however that the shafts have not been clenched, which would be expected in the case of their use with frames and planking, in correlation with their extended length and again with the way they curve along some twothirds of their surviving portions, all seem to indicate that they would have been used in the lower part of the hull, plausibly at the keel or the mast-step.

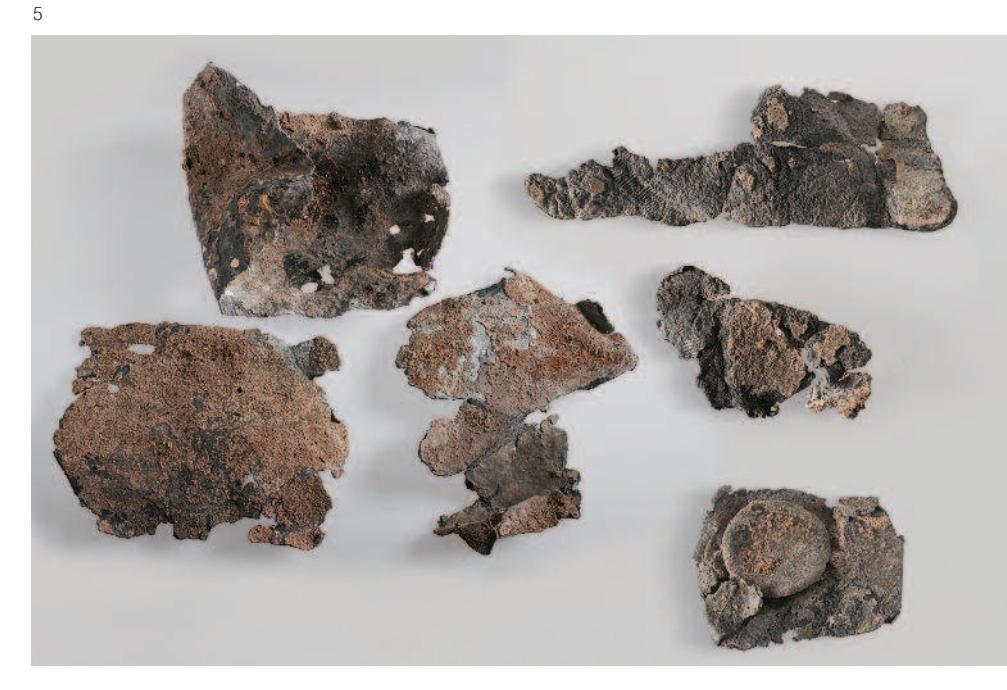
5. FRAGMENTS OF METAL SHEATHING First half of 1st c. BC or earlier Lead

Th. (including patina) 0.0015–0.004 m. From the material retrieved in 1976 (7 July, from a depth of 52 m.) Athens, National Archaeological Museum, X 19015

Several fragments, including six large twisted sheets covered with calcareous concretions and seashells. One sheet is pierced. One fragment shows a low circular projection, which may correspond to a nail head, 0.049 m. in diameter. Two fragments preserve a thin band with incised vertical lines, possibly traces of the tool used for smoothing and attaching that sheet to another. The sheathing of the hull's exterior with lead sheets up to the water line and occasionally well above it is attested since the late 4th c. BC in the Kyreneia shipwreck. The Kyreneia ship was already old when the sheets were applied. The thin strips with peripheral nails from the Porticello wreck (415-385 BC) were interpreted as material for insulating or repairing the joints (seam patches). Lead hull sheathing was common in the Hellenistic period and the Early Roman period on newly built ships, but ceased at the
